Bruce, T., Long, H. orcid.org/0000-0003-1673-1193 and Dwyer-Joyce, R.S. (2018) Threshold Maps for Inclusion-Initiated Micro-Cracks and White Etching Areas in Bearing Steel: The Role of Impact Loading and Surface Sliding. *Tribology Letters*, 66. 111. ISSN 1023-8883

Threshold Maps for Inclusion-Initiated Micro-Cracks and White Etching Areas in Bearing Steel: The Role of Impact Loading and Surface Sliding

T. Bruce¹ · H. Long¹ · R. S. Dwyer-Joyce¹

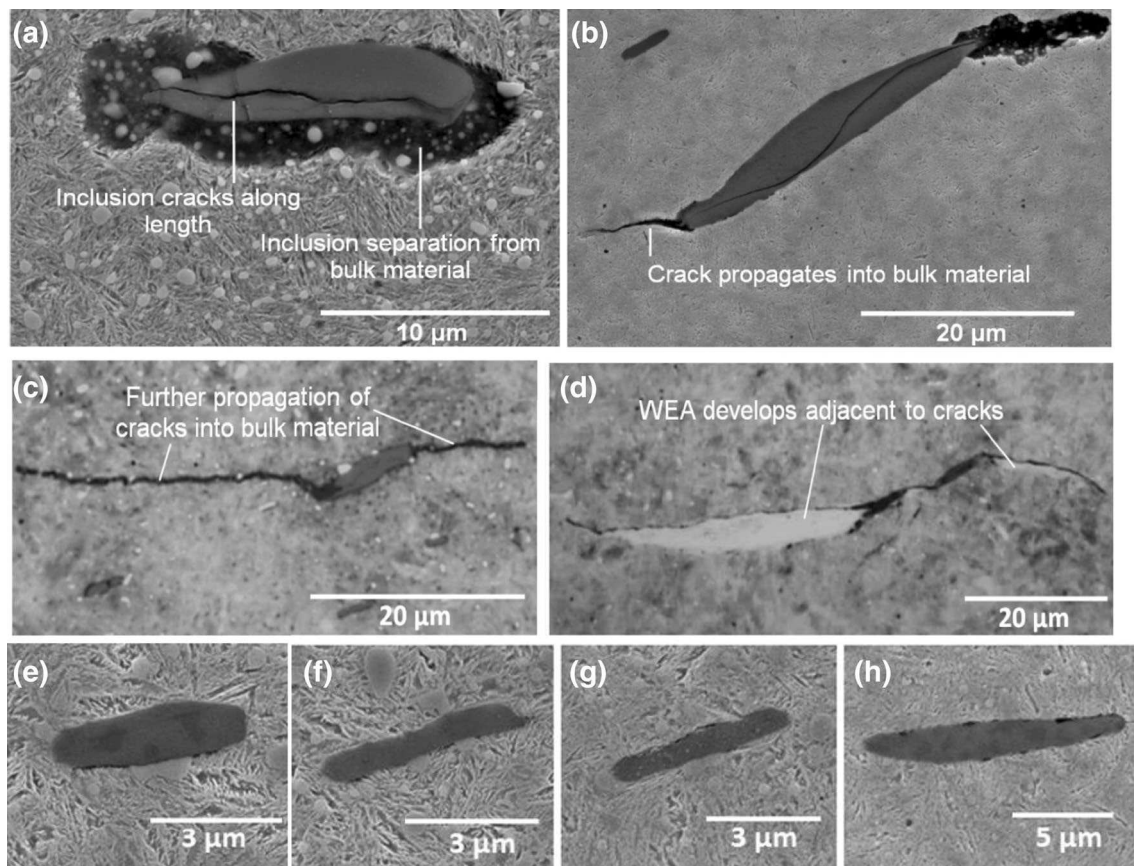
Fig. 1 Four different forms of subsurface-damaged MnS inclusions from a failed WTG planetary bearing: **a** separation of inclusion from the surrounding steel matrix; **b** internal cracking of inclusion; **c** crack

propagation into surrounding material; **d** WEAs attached to these cracks and/or free surfaces; and **e–h** examples of undamaged inclusions at depths of greater than 5 mm from contact surface

inclusion types, carbide elongation, and possible crack initiation at carbides. Figure 8 shows some examples of damage initiation at alumina and titanium inclusions with their EDX analysis while Fig. 9 shows damage at carbides. In general, the main forms of damage were observed at MnS inclusions, which were similar to those found in both failed WTG bearings [45, 46, 49] as shown in Fig. 1 and tested specimens [51].

The creation of a free surface by separation of inclusions from the surrounding steel matrix (shown in Fig. 1a) has been identified as an initiation mechanism for micro-cracks and WEAs in our previous studies [45, 46, 49]. The testing of twin discs found that separation occurred to varying degrees at a wide range of surface traction and contact pressure levels. Separated inclusions were common at depths, under the impact zone of the specimens, near to the location of τ_{\max} . Separation was found at inclusion tips, above and below inclusions as well as completely surrounding inclusions, examples of which are shown in Table 2, Damage I-A. All specimens were carefully washed after etching to prevent

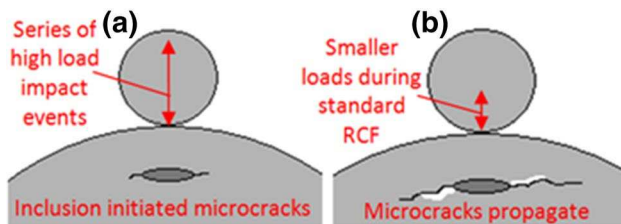
Fig. 2 Importance of impact loading (not to scale), showing a high-impact load event that initiates subsurface micro-cracking, which is subsequently propagated by standard RCF loading

It has been hypothesized that impact loading is a key factor affecting subsurface damage initiation at inclusions [51]. Figure 2 describes a hypothesis, showing that if a high-impact load event happens prior to a series of lesser loading events, then the damage is more serious than that if these events occur in the reverse order, due to the initiation of fatigue cracking at inclusions (this will be analysed in detail in Sect. 2).

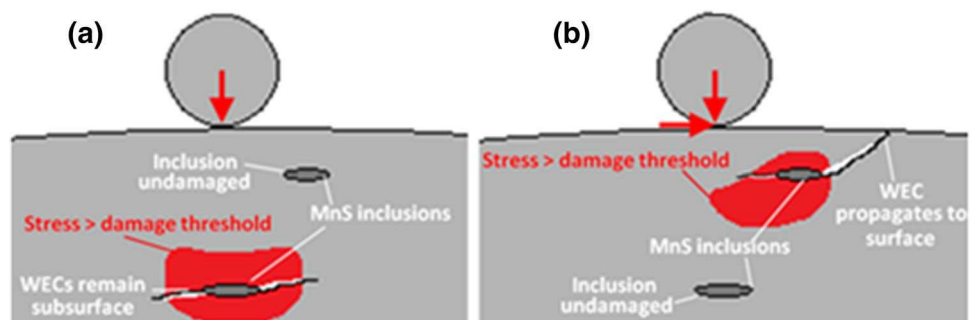
Fig. 3 Importance of surface traction (not to scale): **a** pure rolling: critical stress threshold exceeded relatively deep—micro-cracking at inclusion may never reach surface and cause failure; **b** rolling and sliding: critical stress field shifted closer to surface—micro-cracking at inclusion propagates to surface, leading to failure

The importance of the surface traction caused by sliding between rolling elements and raceways for general applications has been documented [52, 53]. As discussed early, for WTG bearings, significant sliding due to transient operation conditions has been reported and it has been recognized that the surface sliding has an important effect on initiating micro-cracks at subsurface inclusions leading to surface spalling [31, 32, 41–44]. Since surface traction shifts the subsurface high-level stress field closer to the surface, the locations of maximum shear stresses occur at shallower depths. Since cracks have to propagate a lesser distance from shallower inclusions, those cracks initiated at shallower depths have a higher probability of leading to surface damage. The potential importance of surface traction is illustrated in Fig. 3 and will be analysed in detail in Sect. 2.

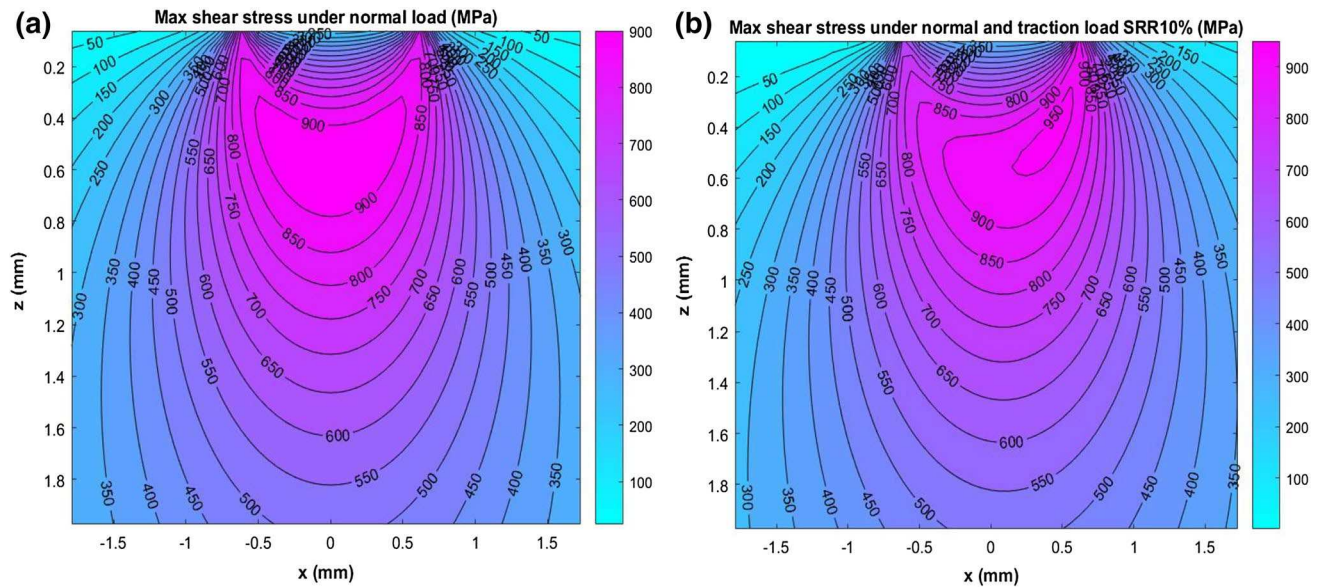
Fig. 4 Subsurface maximum shear stress distributions: **a** under normal load; **b** under combined normal and tractive load ($p_0=3030$ MPa, $a=0.6171$ mm, SRR=10%)

some previous studies [22, 26, 40, 42, 43]. Considering the maximum loading capability of the twin-disc machine and contact stress levels required to initiate subsurface damage, specimens were designed to induce the maximum values of contact pressure p_0 , as 1.79, 2.42, and 3.03 GPa respectively. Figure 4 shows the maximum shear stress distributions when under a normal load and a combined normal and tractive load, respectively, when the contact pressure p_0 is 3.03 GPa.

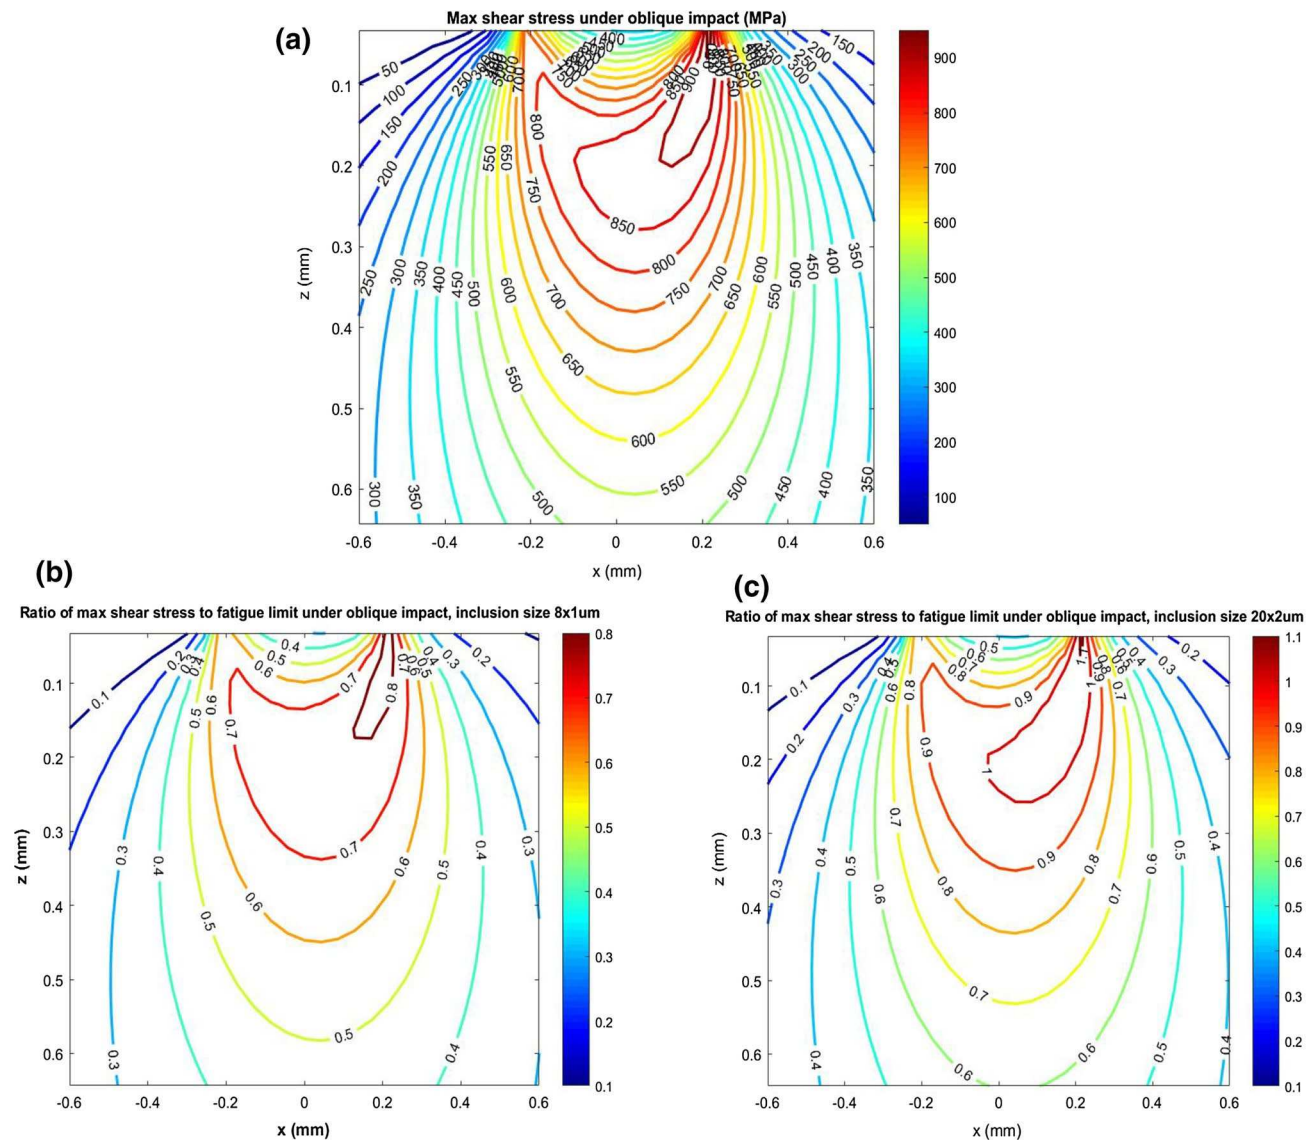
Fig. 5 Under oblique impact: maximum shear stress τ_{\max} and ratio of maximum shear stress to fatigue limit τ_{\max}/σ_w : **a** max shear stress τ_{\max} ; **b** ratio τ_{\max}/σ_w for inclusion size $8\ \mu\text{m} \times 1\ \mu\text{m}$; **c** ratio τ_{\max}/σ_w

for inclusion size $20\ \mu\text{m} \times 2\ \mu\text{m}$. ($u_0=0.3535\ \text{m/s}$, $p_0=2759\ \text{MPa}$, $r_a=0.2145\ \text{mm}$, coefficient of friction=0.1, impact angle 45° ; steel hardness $H_v=760$)

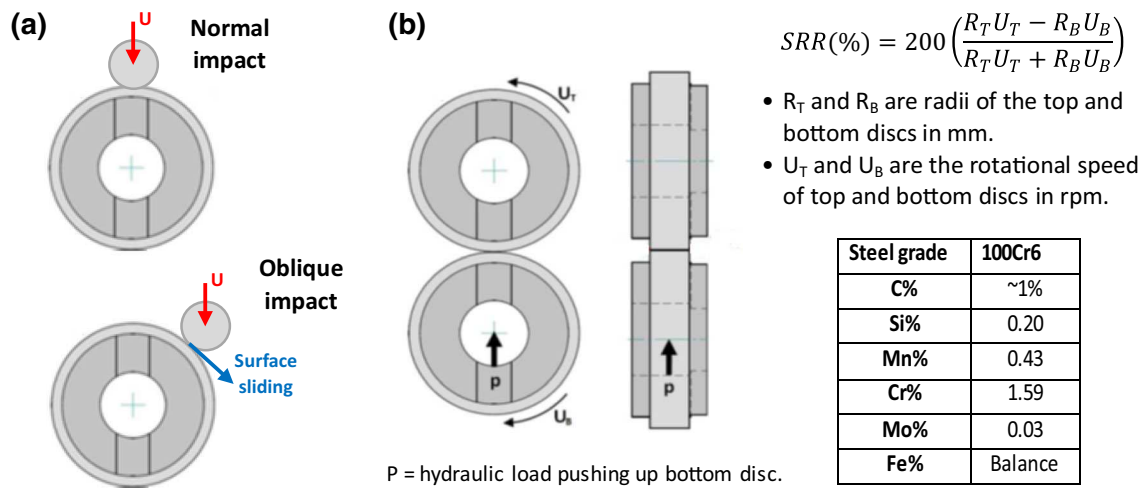
Fig. 6 Illustration of experiments: **a** impact test; **b** rolling contact fatigue test of twin discs

The impact test rig described in Ref. [51] was used to seed damage in the test specimens at two opposite locations on the circumference of each disc representing bearing raceways. As illustrated in Fig. 6a, the impact rig can also create oblique impacts, allowing the impacting ball to hit the specimen at an angle of 45° to the tangent, introducing both normal load and surface traction. 50,000 repeated oblique impacts were applied at the impact locations. Any location further than a few millimeters away from the point of impact was assumed to be not directly affected by impact loading and so the effects of subsequent RCF tests without pre-seeded impact damage could be investigated and compared to the pre-damaged impact zone.

The RCF testing using twin discs, illustrated in Fig. 6b, was designed to investigate early stage damage after comparatively few RCF load cycles (2×10^5) to that of

SRR from 0.2 to 10% was tested. Specimens representing raceways were positioned on the top shaft that rotated at rotational speed U_T and those representing the rollers on the bottom shaft rotated at speed U_B , where $U_T < U_B$. The lower disc can be controlled to rotate faster than the upper one in order to introduce sliding, controlled by a computer.

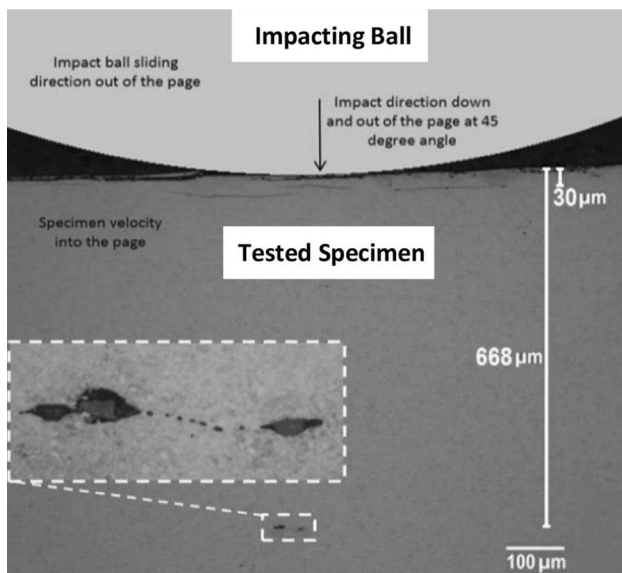
Fig. 7 Subsurface cracks beneath impact zone of Disc 11 (with approximate position of impacting ball superimposed to illustrate the scale of the ball in comparison to the cracks)

Cracks that were linked to the surface were found in specimens that had been subjected to high surface traction and high contact pressure. Subsurface cracks, which did not appear to have any link to the surface, were found in many of the specimens. Figure 7 shows three subsurface cracks, a few hundred micrometres in length, directly under the impact zone found in Disc 11. Since the cracks were very near to the surface (30 μm), it seemed likely that surface traction played a role in their initiation or propagation. These cracks were much longer than any found away from the point of impact, the longest of which were of the order of tens of micrometres in length. The figure also displays a damage initiating pair of inclusions at a depth of 668 μm (greater than the depth of

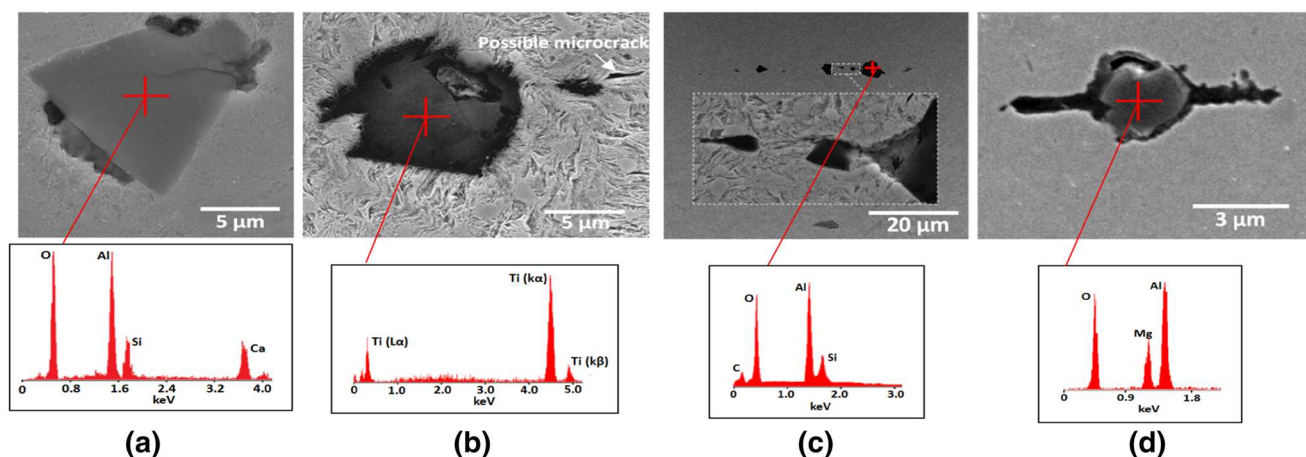
Fig. 8 Damage at other types of inclusions and EDX analysis: **a** internal cracking of alumina inclusion; **b** micro-crack close to titanium inclusion; **c** possible damage at alumina inclusion; **d** micro-cracks at either side of alumina inclusion

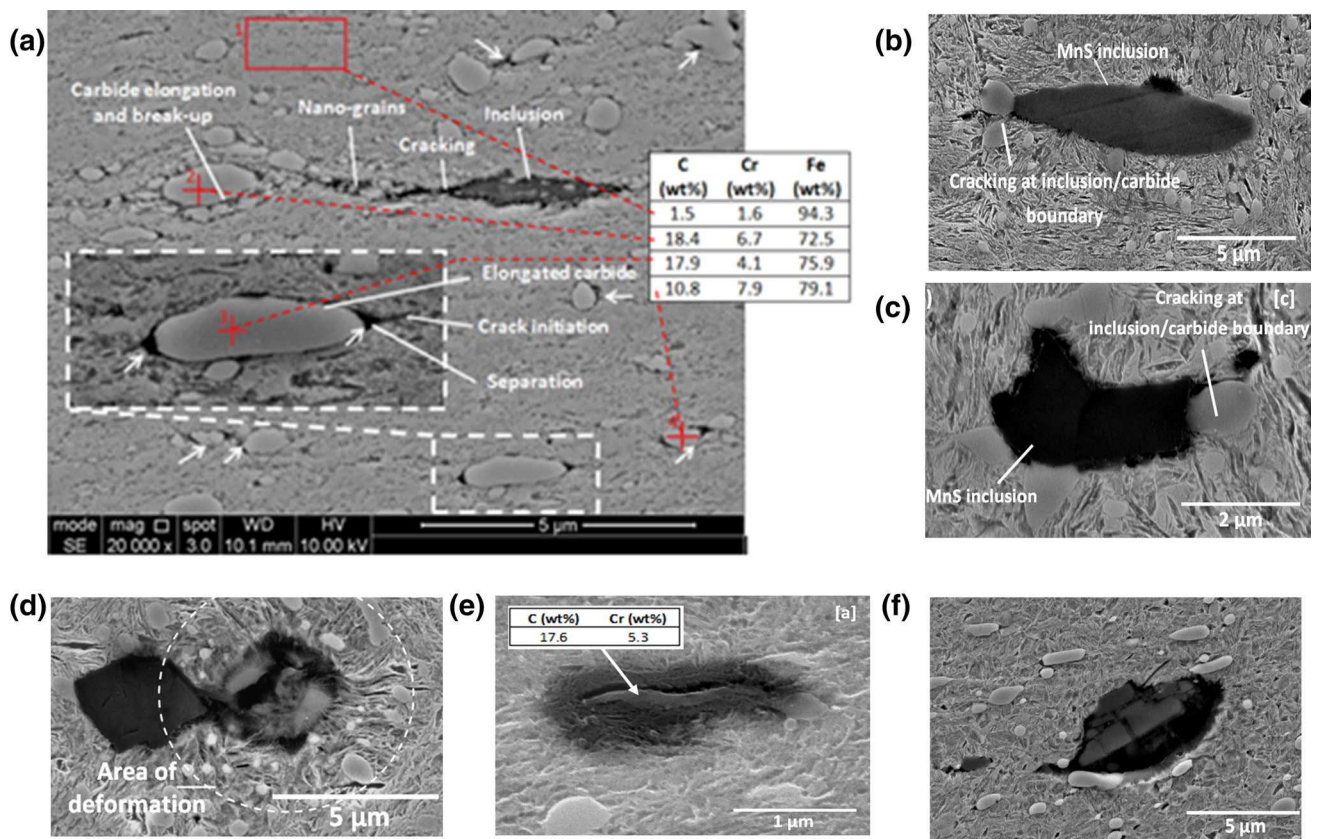
Fig. 9 Damage at carbides and boundaries with inclusions: **a** EDX analysis of the labelled carbides (Disc 8); **b, c** cracking at MnS inclusion/carbide boundary (Discs 8 and 11); **d** dissolution of carbides in

close vicinity of MnS inclusion (Disc 11); **e** severely elongated separated carbide (under impact zone of Disc 11); **f** elongated carbides around separated/cracked MnS inclusion (Disc 12)

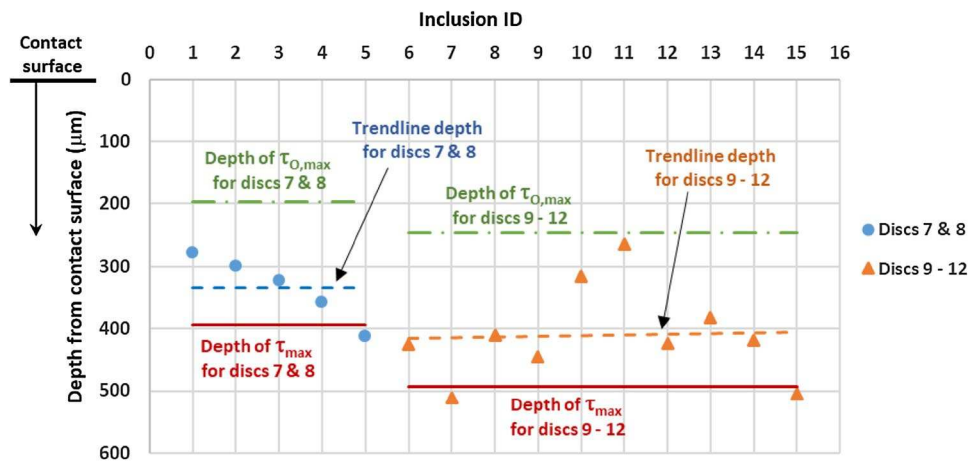
Fig. 10 Depths of WEA-initiating inclusions in tested discs and comparison with depths of maximum shear stresses

The depth of each of the WEA-initiating inclusions was investigated. Five were found in Discs 7 and 8, which were exposed to the second highest contact pressure (2.42 GPa), and 11 in Discs 9–12, which experienced the highest contact pressure (3.03 GPa). The RCF test parameters and the calculated maximum shear stresses are shown in Table 1. The depths of each of the WEA-initiating inclusions are presented in Fig. 10, together with the depths of the RCF maximum shear stress zones, τ_{\max} and $\tau_{0,\max}$. One WEA-initiating inclusion was close to the surface (Table 3, Disc 12—Inclusion 16, depth 37 μm), and was linked to a surface breaking crack. Since it cannot be proved whether the crack was initiated in the subsurface or on the surface, it was decided to ignore it when calculating the trend line depth of WEA inclusions in Discs 9–12. The trend line depths calculated from the

15 WEA-initiating inclusions are plotted in Fig. 10. For both datasets; Discs 7–8 and Discs 9–12, the trend line depth corresponded most closely with the RCF maximum shear stress, τ_{\max} , however, closer to the contact surface, affected by the surface traction and impact stresses as discussed in Sect. 2 and illustrated in Figs. 4 and 5, respectively. One limitation of these results is that the test sample sizes are fairly small, since only 16 WEA-initiating inclusions were found.

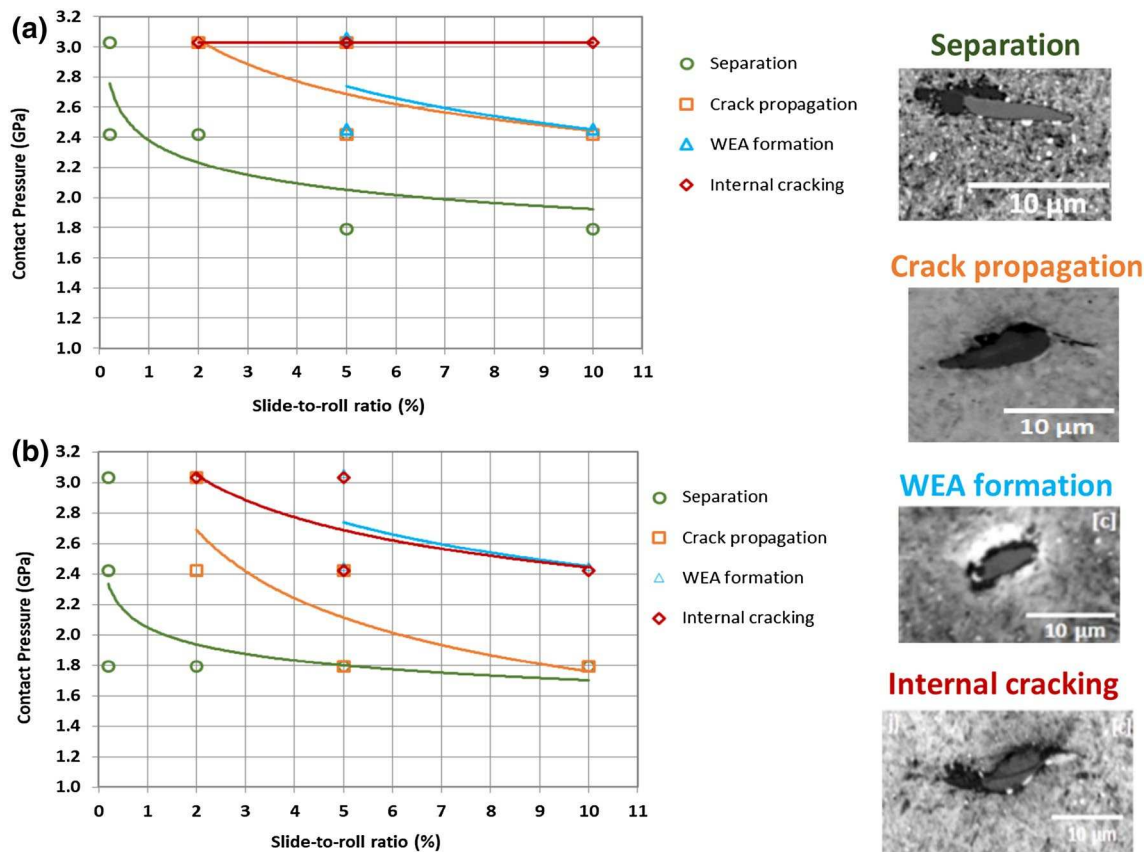
Fig. 11 Thresholds of contact pressure and SRR for four different forms of inclusion-initiated damage: **a** specimens with no pre-seeded damage; **b** specimens pre-damaged with impact loading

pressures and surface tractions at which the damage was found. Figure 11 presents the thresholds of contact pressures and SRRs while Fig. 12 uses the mean traction coefficients measured during RCF testing. Comparing results in this way allows the minimum required levels of different damage-initiating factors, taking into account their combined effects, to be estimated. Any point above the

plotted trend lines using the obtained data points from the tested specimens is above the threshold required to initiate damage at inclusions. It is clear that increasing contact pressure and sliding within the ranges investigated, caused increasing levels of damage. It is assumed that if a specimen has experienced damage at a lower contact pressure and sliding level, then it will do so at higher levels,

However, increased levels of SRR above certain contact pressure levels were required for the separation to spread away from inclusion tips into the steel matrix (Damage I-B). This occurred in Disc 4 at the lowest contact pressure of 1.79 GPa (damage image is shown in Table 2, Disc 4), when SRR was 10%, as shown in Fig. 11.

no internally cracked inclusions were found. As shown in Figs. 11a, b and 12a, b, the thresholds of contact pressure for specimens with pre-impact damage were lowered in comparison with the trend lines for those without impact damage, indicating that the inclusion internal cracking could occur at much lower contact pressures when under higher SRRs, if the specimens were pre-damaged with impact loading.

As shown in Figs. 11 and 12, crack propagation from inclusion tips occurred at lower contact pressures and SRRs than that for inclusion internal cracking, which offers further evidence that the latter is not required to initiate the former [45]. It was clear that the pre-damaged specimens had lower contact pressure and surface traction thresholds for this damage mechanism to occur, further backing up the hypothesis that impact loading may accelerate damage of WTG bearings.

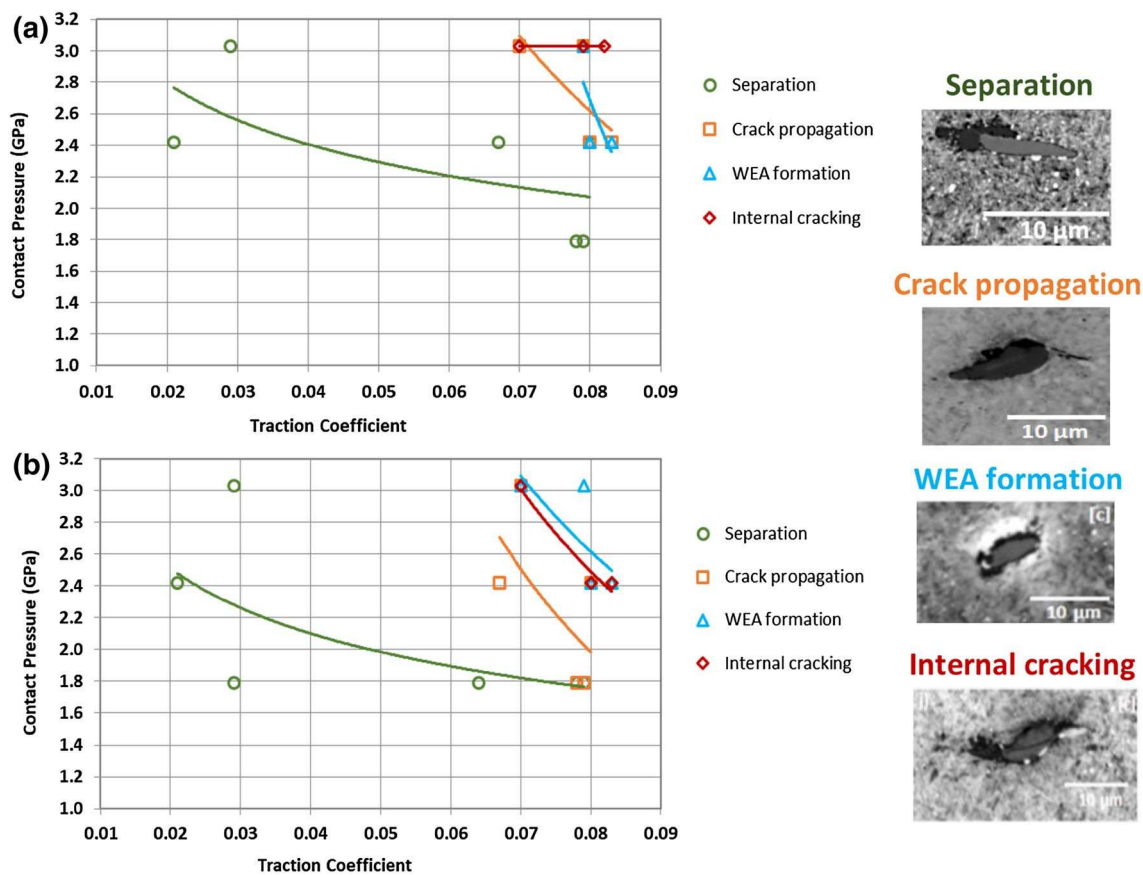
Fig. 12 Thresholds of contact pressure and traction coefficient for four different forms of inclusion-initiated damage: **a** specimens with no pre-seeded damage, **b** specimens pre-damaged with impact loading
